ASOS MODIFICATION NOTE 5 (for Electronics Technicians)

SUBJECT Firmware Upgrade for Light Emitting Diode Weather Indicator

(LEDWI)

PURPOSE Update firmware on the present weather sensor microprocessor

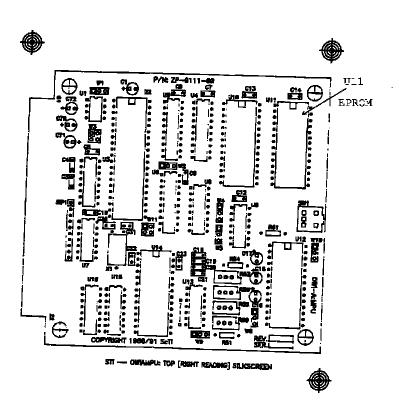
- 1. At the DCP, turn the LEDWI circuit breakers to 'OFF'.
- 2. At the LEDWI, open the electronics enclosure door.
- 3. Remove the MPU card located in the card cage, third slot from the top.
- 4. Referring to the attached assembly drawing on page 2, carefully remove the EPROM located in the U11 position.

- 5. Install the new Rev 3.61 EPROM in the U11 position of the MPU card.
- 6. Reinstall the MPU card in third slot of the card cage.
- 7. Close and secure the door of the electronics enclosure.
- 8. At the DCP, turn the LEDWI circuit breakers to 'ON'.
